EFFECT OF SULFUR IN JP-5 FUEL ON HOT CORROSION OF COATED SUPERALLOYS IN MARINE ENVIRONMENT

FINAL SUMMARY REPORT
APRIL 1, 1967 TO MARCH 31, 1968

BY
H. T. QUIGG AND R. M. SCHIRMER

PHILLIPS PETROLEUM COMPANY - RESEARCH DIVISION REPORT 5058-68R

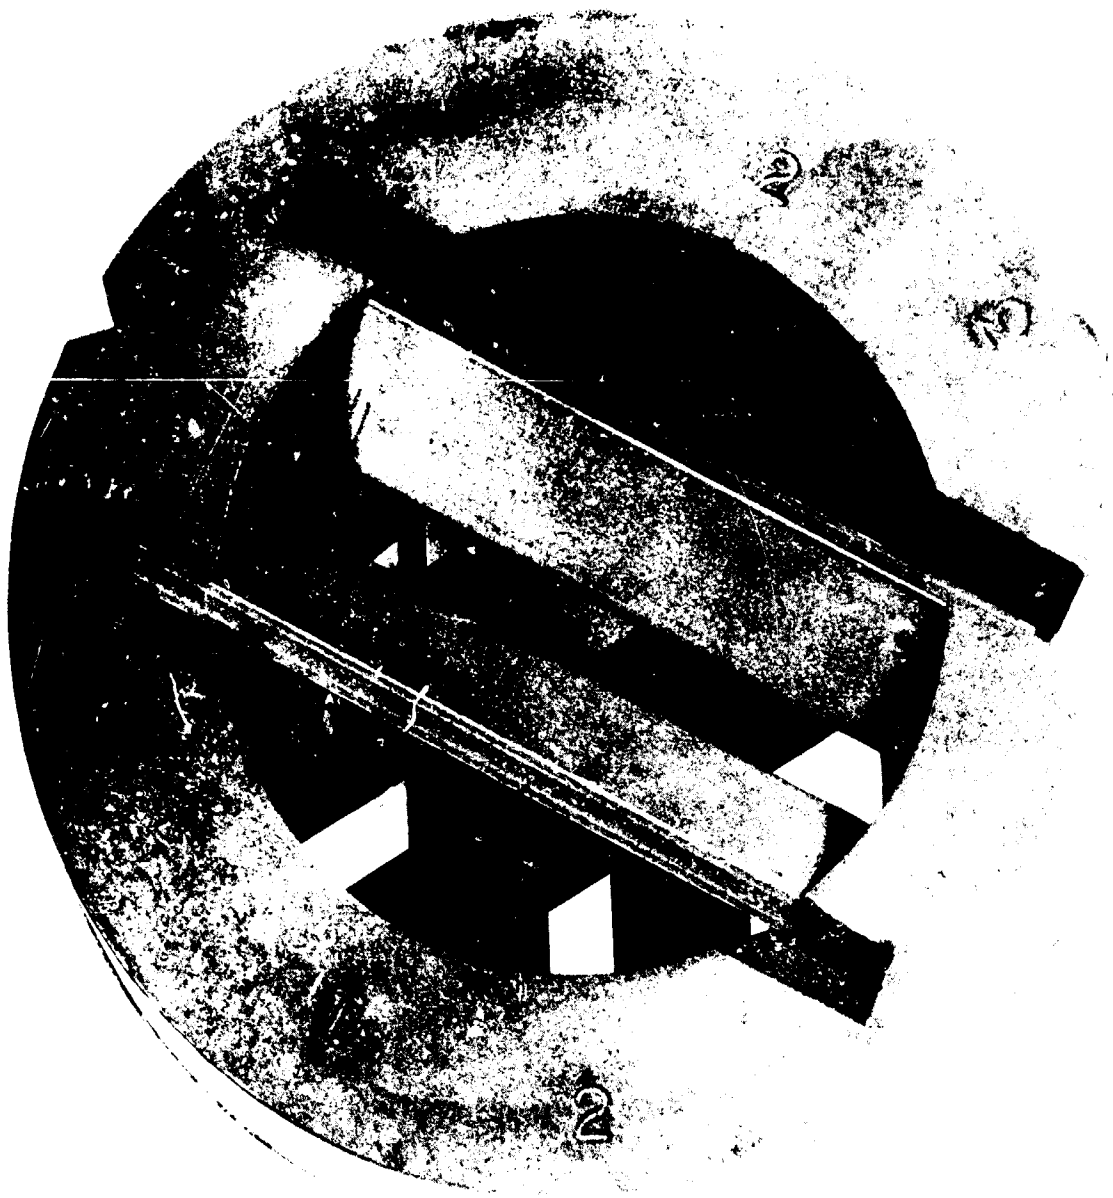
FIGURE 51
SPECIMENS MOUNTED IN CASCADE

Three holders were stacked to form a cascade, with each successive holder rotated 120 degrees to prevent channeling of the hot-gas flow. A view of the cascade as assembled for mounting in the test rig is shown in Figure 51.

2X MAGNIFICATION

In all tests the three stages of the cascade (Figure 51) were loaded with six new specimens prior to the start of a test. The cyclic test was operated in periods of 5-hours with the fuel nozzle, combustor dome and liner, sea water injection tubes and test specimens examined at the end of each period. The basic plan for the experiments consisted of removal of one test specimen, with replacement, at each 5-hour period for the first five periods and then continuing the test to 55 hours, or until visual inspection of the specimens indicated heavy attack and the possible loss of a specimen with further exposure to the hot gasses. To minimize any effect of position in the cascade, a system of rotation of the position of specimens was used where the specimen holder in the first stage of the cascade was moved to the third stage and the other two holders advanced one position at each five hour interval. The order of specimen removal is shown in Table 20. For test conducted at the 1400, 1600 and 1800 F conditions the order of specimen removal was modified, as shown in Table 21, with each specimen exposed in each of the three stages of the cascade. Thus total exposure on each specimen was 15, 30 or 45 hours.
